# Four Firefighters Injured In Lithium-Ion Battery Energy Storage System Explosion - Arizona

Mark B. McKinnon  
Sean DeCrane  
Stephen Kerber

UL Firefighter Safety Research Institute  
Columbia, MD 20145

July 28, 2020

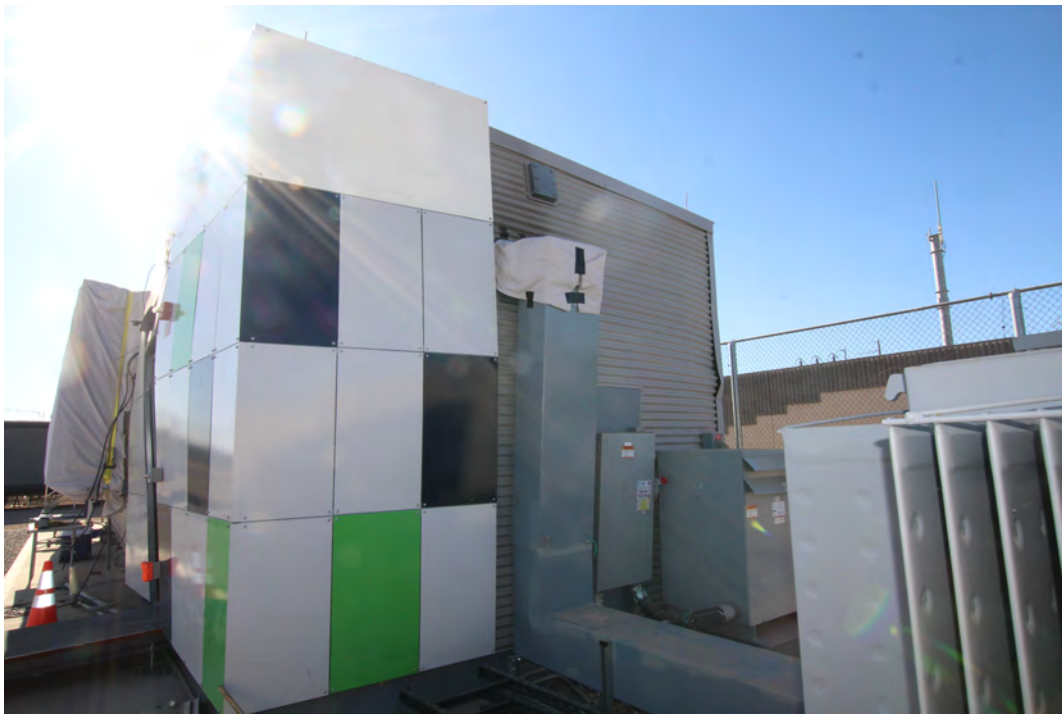
Figure 4.4: Photograph of the ESS after the incident from the northeast [13].

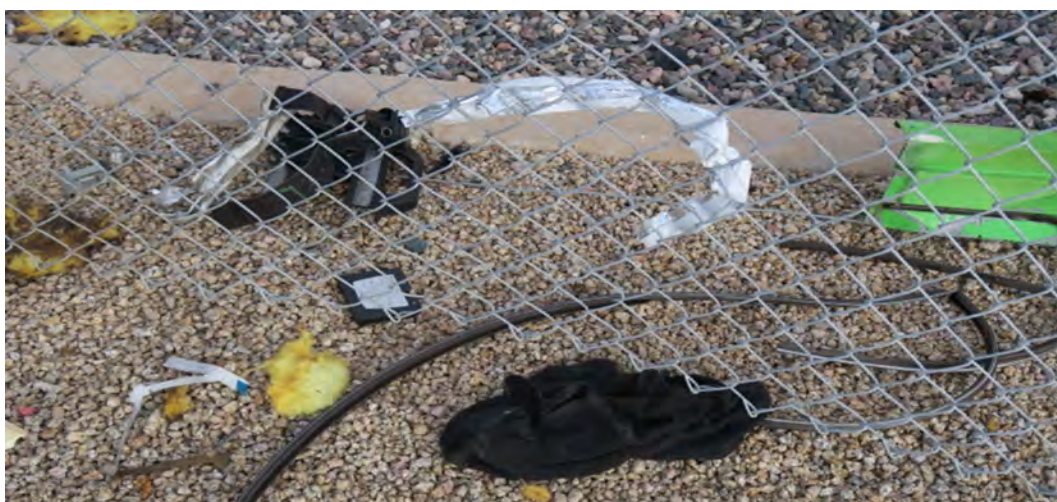
Figure 4.17: Photograph of firefighter equipment removed by the fence during the deflagration [6].
