# Four Firefighters Injured In Lithium-Ion Battery Energy Storage System Explosion - Arizona

Mark B. McKinnon  
Sean DeCrane  
Stephen Kerber

UL Firefighter Safety Research Institute  
Columbia, MD 20145

July 28, 2020

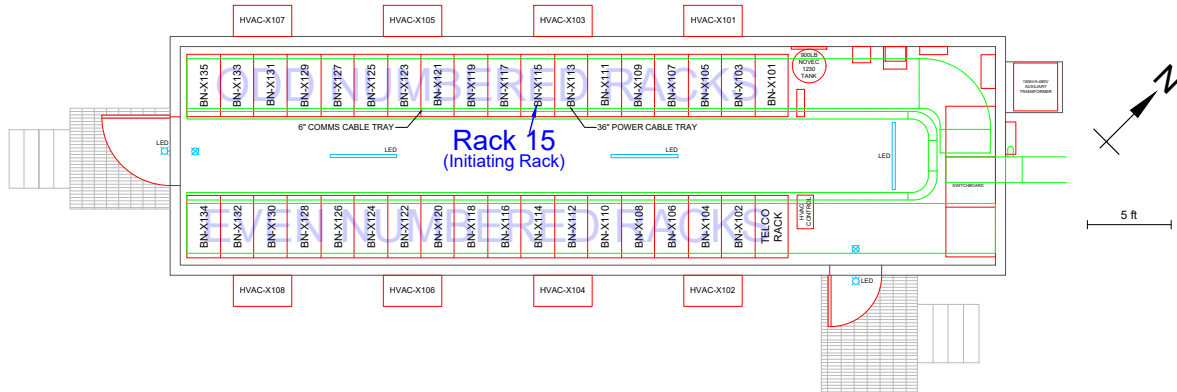
A schematic of the ESS is provided in Figure 4.7. A photo of a typical battery rack installed in the system is displayed in Figure 4.8. The racks also housed a battery protection unit, a node controller, and an inverter. At the time the ESS communication system first indicated an anomaly, all of

the batteries in the system were charged to 90% state-of-charge (SOC). The ESS was monitored remotely via wireless communication, which was lost approximately 50 minutes after the initial anomaly [11].

Figure 4.7: Schematic of the ESS (adapted from [15]).

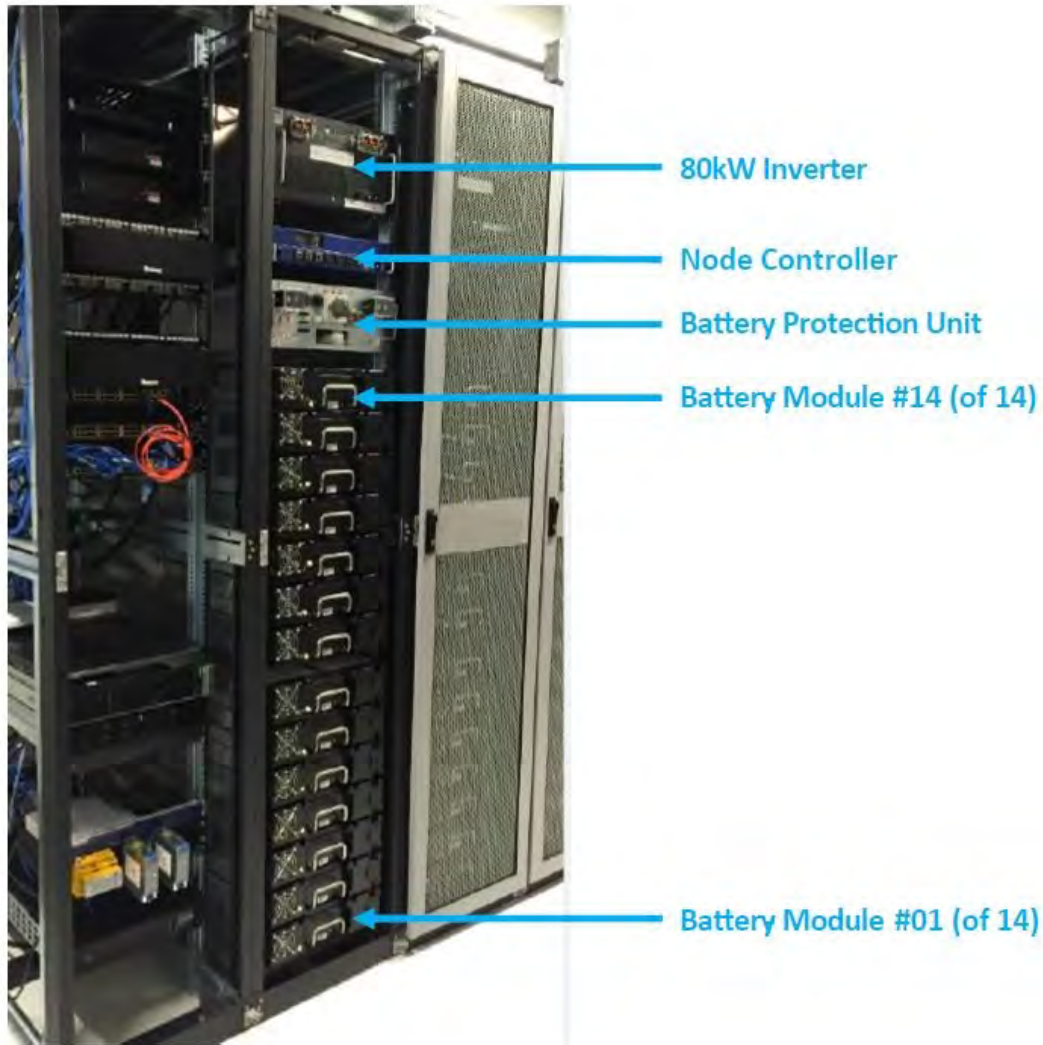
Figure 4.8: Photo of an example battery rack in an ESS [15].

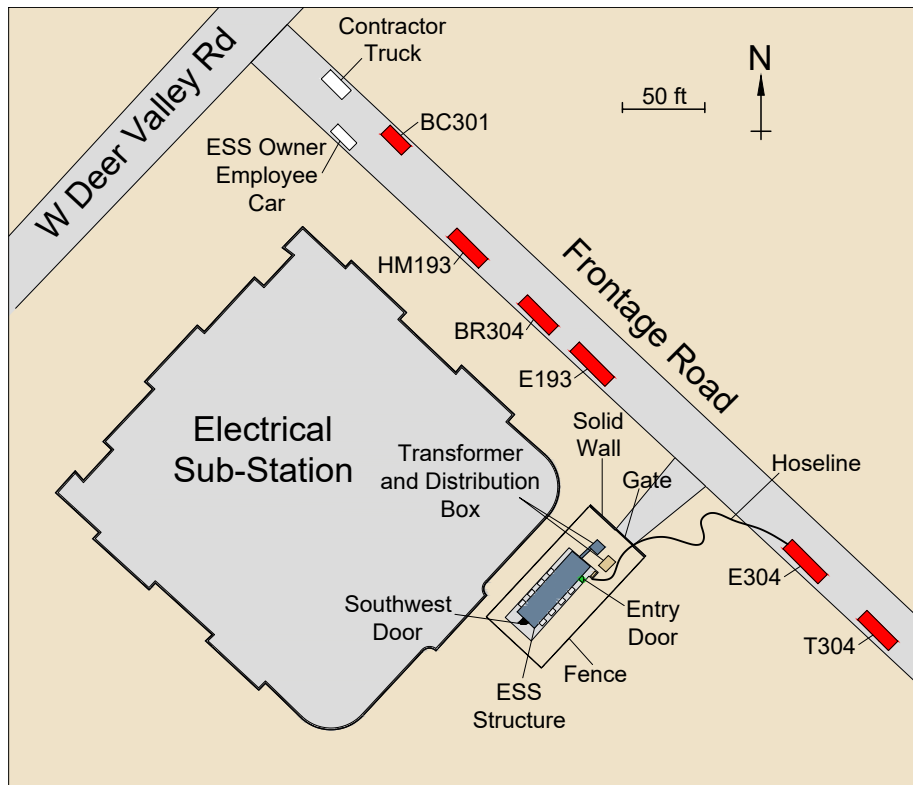
gate to the fenced area (above 50 ppm and 500 ppm, respectively). The team walked through the desert outside the fenced area to define the extent of the hot zone and found hazardous conditions at all locations where the gas/vapor cloud was visible. The HAZMAT team inspected the outer surface of the structure using a TIC to determine if an active fire was present in the ESS. A relatively small hot spot (~6 in. x 24 in.) with a maximum temperature of approximately 130°F was identified on the northwest side of the ESS at the approximate location of the Rack 15 inverter [6, 9]. The HAZMAT team reported back gas levels and TIC temperatures to BC301 BC, who had set up the command vehicle (BC301) north of the gate on the frontage road. A diagram of the approximate locations of each vehicle relative to the ESS is provided in Figure 4.10.

Figure 4.10: Diagram representing approximate locations of vehicles relative to the ESS [6, 7]

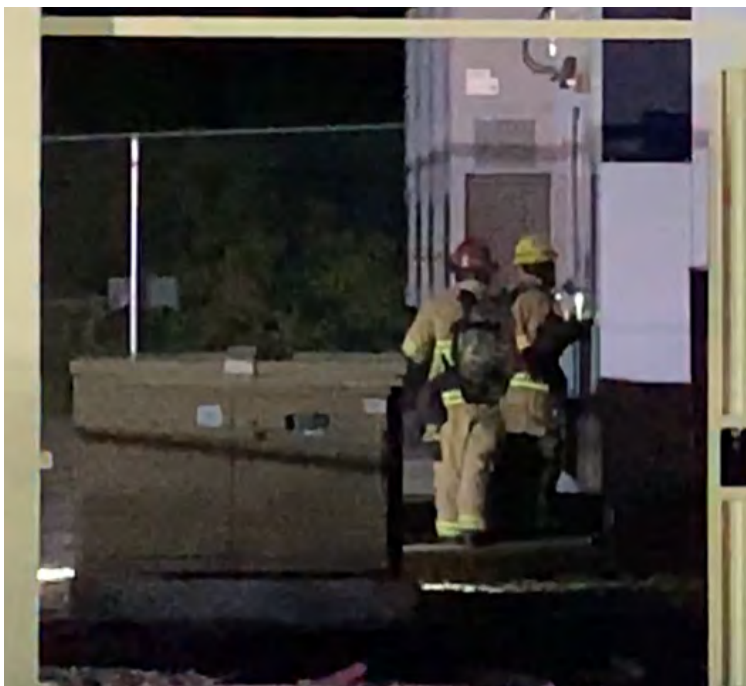
the container with the TIC. A visible white gas/vapor mixture immediately poured out of the open door while the HAZMAT team measured gas concentrations and continued to monitor the ESS. Images extracted from a video recorded on the scene as the door was opened are displayed here. Figure 4.11 displays E193 Capt (red helmet) and E193 FE (yellow helmet) just prior to E193 FE opening the door to the ESS. The hoseline that the HAZMAT team had brought into the hot zone in preparation of opening the door can be seen at the bottom of the image at the entrance gate. Figure 4.12 displays E193 Capt, E193 FE, and HM193 FF1 (far left of image) approximately 5 s after the door was opened. Dense gases and vapors can be seen in the image in Figure 4.12 flowing out of the ESS through the door.

Figure 4.11: Image of the HAZMAT team just prior to door opening [14].

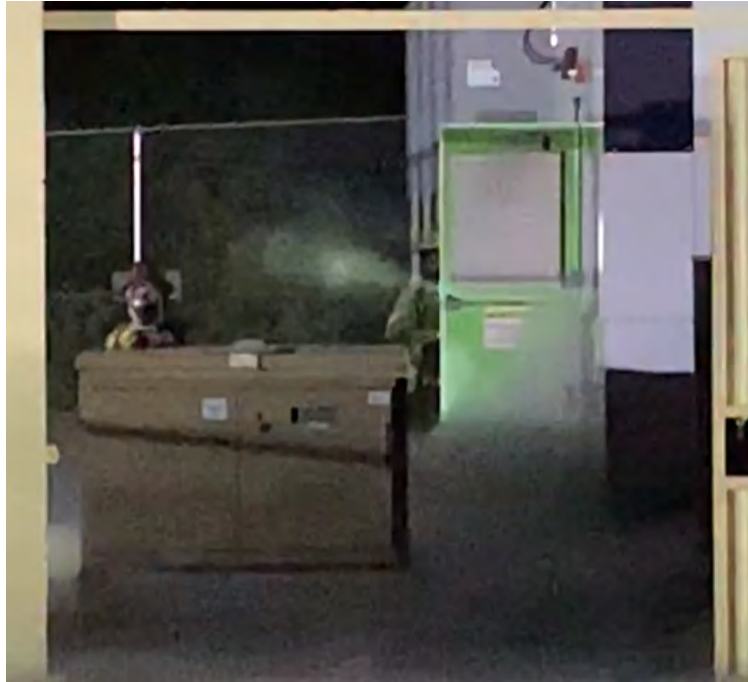
Figure 4.14: Image of the HAZMAT team 33 s after opening the door [14].

it was. HM193 FF1 advised that he could see the top of the round object without the TIC as the gas/vapor mixture flowed out of the doorway but he did not know what it was [6]. This indicates that prior to the deflagration event, visibility was such that the back wall of the ESS was visible, the gas/vapor mixture was flowing out of the doorway from high elevation, and the level of the gas/vapor mixture in the ESS had descended to approximately 5 ft above the floor. A photograph facing into the ESS taken from the entry door after decommissioning is presented in Figure 4.15. This image shows the red suppression agent storage tank, which is the object the HAZMAT team was able to see just prior to the deflagration event.

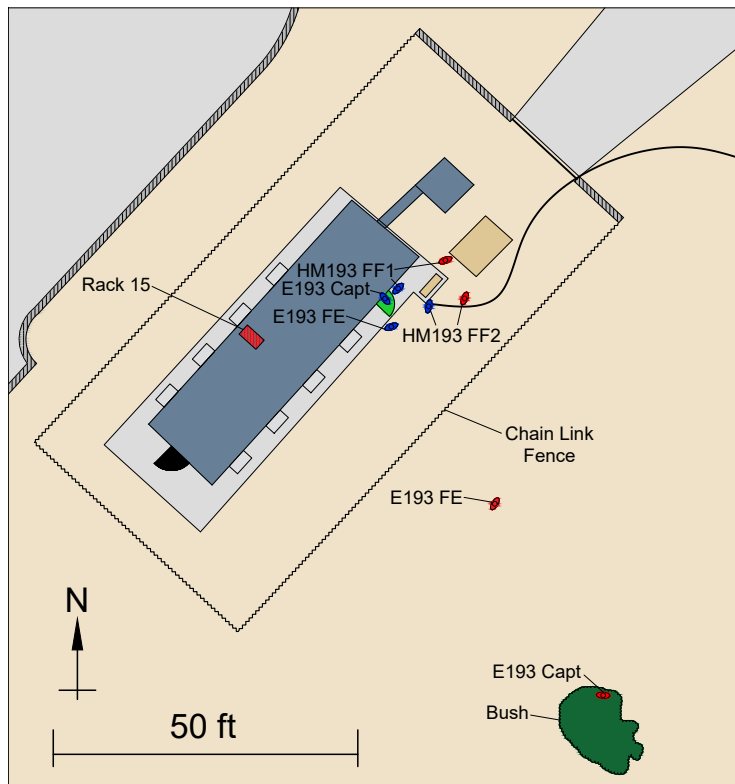
The approximate locations of the members of the HAZMAT team are displayed in Figure 4.16, in which positions just prior to the deflagration are displayed in blue and approximate positions after the deflagration are displayed in red. E193 Capt was at the door, E193 FE was back and to the left at a 45-degree angle from the door, HM193 FF1 was to the right of the door with a multi-gas meter, and HM193 FF2 manned the hoseline at a 45-degree angle back and to the right of the door [6].

Figure 4.16: Diagram representing the locations of firefighters just before the deflagration event. Approximate positions prior to the deflagration event are displayed in blue, and approximate positions after the deflagration event are displayed in red [6].

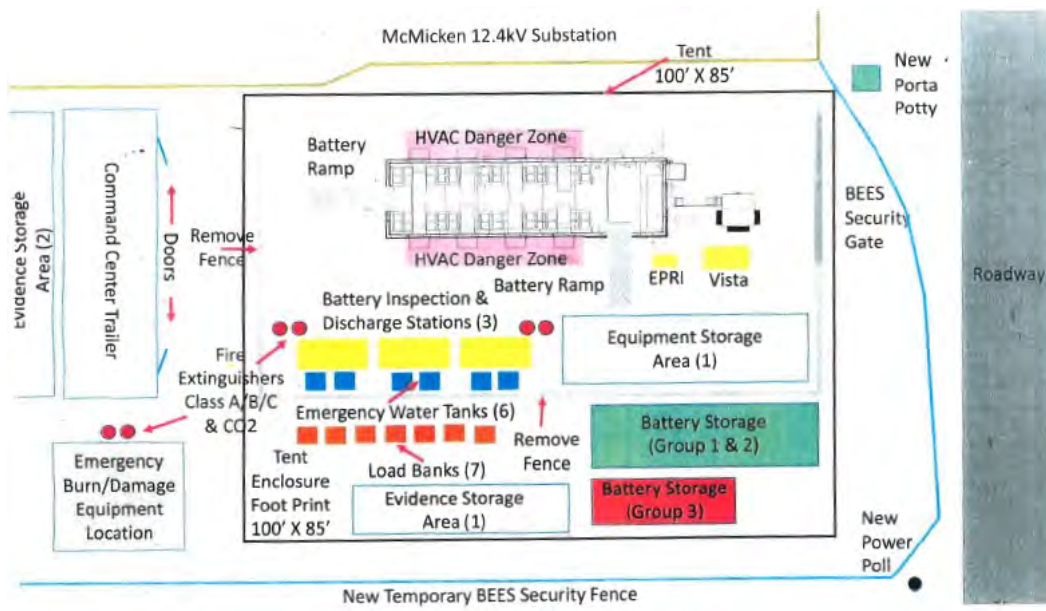
After the fire department transferred the ESS site in this incident back to the owner, personnel from the company that owned the ESS first investigated the site with a drone to provide optical access to the interior of the ESS while not exposing humans to potentially hazardous materials. A tent and a temporary fence were constructed around the ESS site to protect the structure and all equipment required for decommissioning from possible adverse weather and intruders. A map of the site during decommissioning is provided in Figure 8.1. The decommissioning process involved progressing from rack to rack inside the structure, disconnecting all electrical connections and cables, and transferring each individual module from inside the ESS to an inspection and discharge station outside the structure. At each station, the battery was connected to a battery management system as well as a thermal load bank and allowed to discharge to approximately 2% SOC. The battery modules were stored on rack shelves in one of two structures, with the differentiating criterion between the two structures being batteries that exhibited issues while discharging, and those that did not exhibit issues while discharging. Ultimately, all battery modules outside of Rack 15 showed no internal damage to any of the battery cells and discharged with minimal issues. The entirety of Rack 15 was sent to a forensic laboratory to attempt to determine the root cause of the thermal runaway event [11].

All technicians involved in the decommissioning process wore PPE, and fire safety and first aid equipment was readily available on the site. With three inspection and discharge stations available, the entire decommissioning process required almost two months to safely discharge, inspect, and store all of the battery modules. This process ensured that none of the battery cells would undergo thermal runaway while in storage, isolated the origin, and confirmed all damage was confined to the modules in Rack 15.

Figure 8.1: Map of decommissioning operation surrounding the ESS [11].
